# Manhole Inspection Summary

Manhole # S41W1\_007MH

Insp Date: **7/21/08 3:38 PM**

**Location** Address: **Arsan Ave**

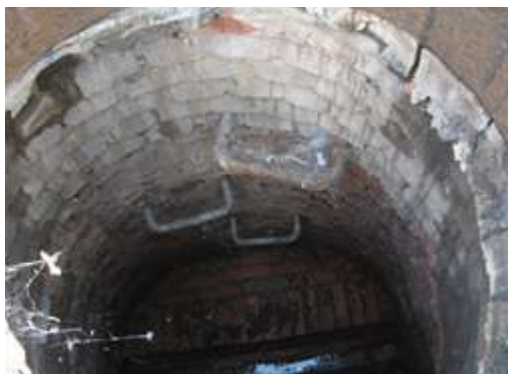
Count: **3** Missing: **0** ☐ Corroded

steps

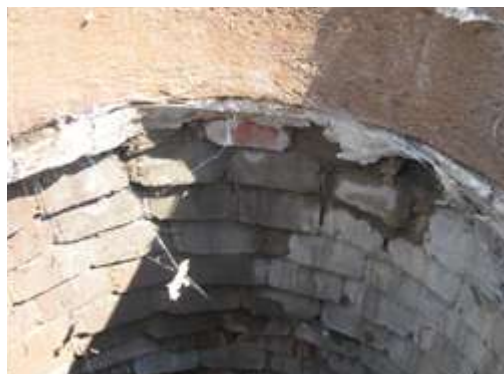
Defect 2

Condition: ☐ Sound ☒ **Cracked** ☐ Root Intrusion ☒ **Loose Brick** ☐ Deteriorated

loose bricks

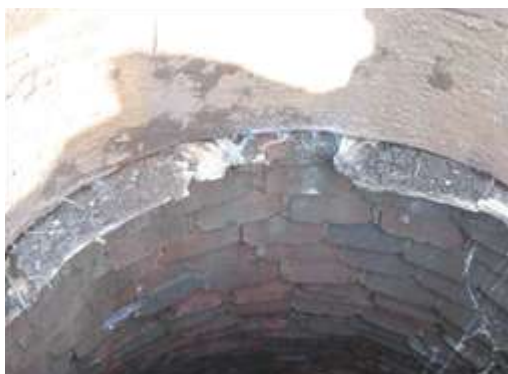
Defect 1

Infiltration: ☐ None ☐ Joint ☒ **Cracks** ☐ Mortar ☐ Roots ☐ Wall

cracked chimney

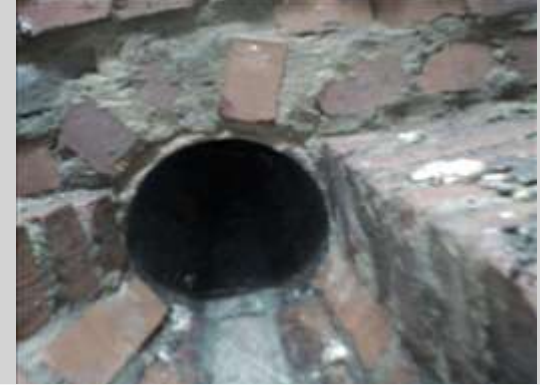
12 O'Clock Outflow

8 in. Circular Gravity Sewer  
Pipe Out @ 12 O'Clock

Pipe Height: **8.4** (in.) Rod and Bar (Angled)  
Pipe Material: **Clay** ☐ Pipe Lined  
Invert Depth: **7.30** (ft.) Flow Characteristics: **Slow**  
Deposits: ☒ None ☐ Mud ☐ Sludge ☐ Debris ☐ Grease  
Silt Depth: (in.) Deposits Extent:  
Infiltration: **None** Pipe Seal Cond: **Sound**

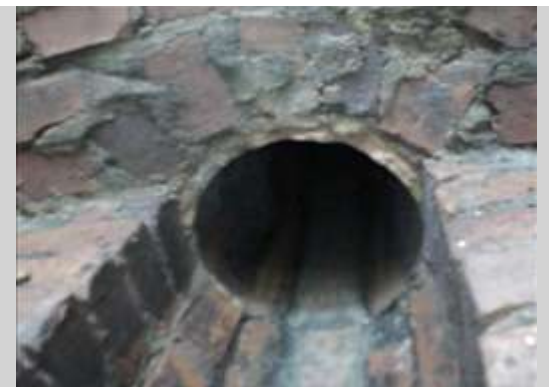
6 O'Clock Inflow

8 in. Circular Gravity Sewer  
Pipe In @ 6 O'Clock

Pipe Height: **8.4** (in.) Rod and Bar (Angled)  
Pipe Material: **Clay** ☐ Pipe Lined  
Invert Depth: **7.22** (ft.) Flow Characteristics: **Slow**  
Deposits: ☒ None ☐ Mud ☐ Sludge ☐ Debris ☐ Grease  
Silt Depth: (in.) Deposits Extent:  
Infiltration: **None** Pipe Seal Cond: **Sound**

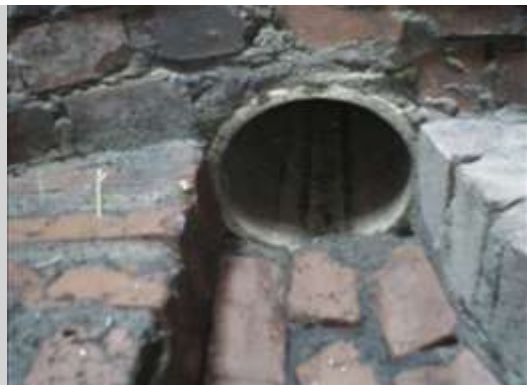
9 O'Clock Inflow

8 in. Circular Service Sewer  
Pipe In @ 9 O'Clock

Pipe Height: **8.4** (in.) Rod and Bar (Angled)

Pipe Material: **Clay** ☐ Pipe Lined

Invert Depth: **7.04** (ft.) Flow Characteristics: **None**

Infiltration: **None**

Pipe Seal Cond: **Sound**
